## ***ENGINEERING REPORT***

### **FAA CONTRACT NO. DTFA03-02-C-00044 PHASE 1, CLIN 0001f (TASK 6) - PRE-TEARDOWN INSPECTION REPORT**

This report supports Task 6 of FAA Contract No. DTFA03-02-C-00044. Various NDT and visual inspections were accomplished on panels which were removed from aircraft N474DA, a Boeing 727-232. The pre-teardown inspections were conducted after aircraft disassembly and prior to teardown and destructive testing. This report provides details and results of the inspections, including procedures used, locations and documentation of defect indications noted, detailed fastener parameters, condition of the panels after aircraft disassembly, and a comparison of the Field Inspections previously accomplished.

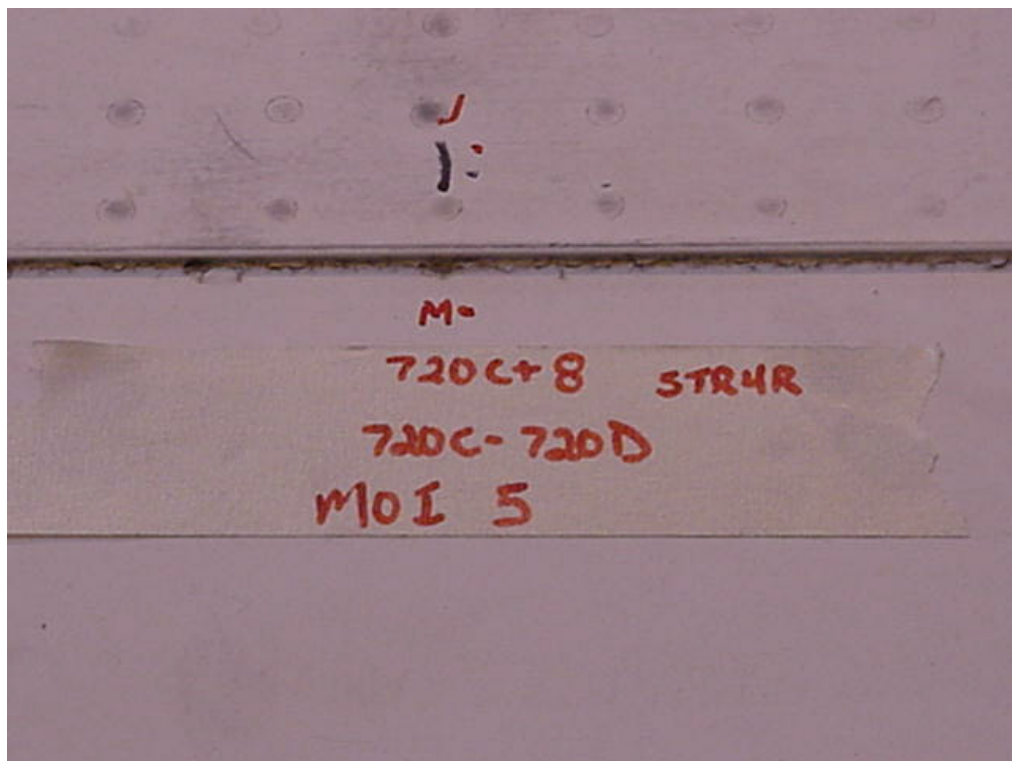
Figure F-16. MOI indications (1 indication at 1 fastener) found between BS 720C and BS 720D on the lower row of the longitudinal lap joint at stringer 4R.

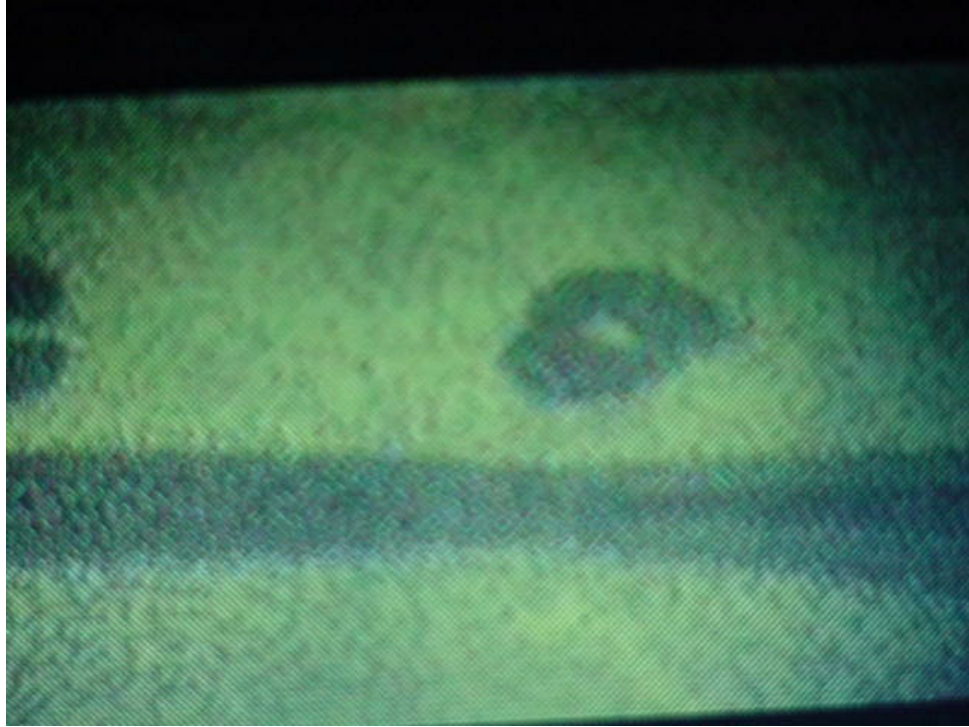
Figure F-17. Screen representation of MOI indication at rivet #8 between BS 720C and BS 720D on the lower row of the longitudinal lap joint at stringer 4R.

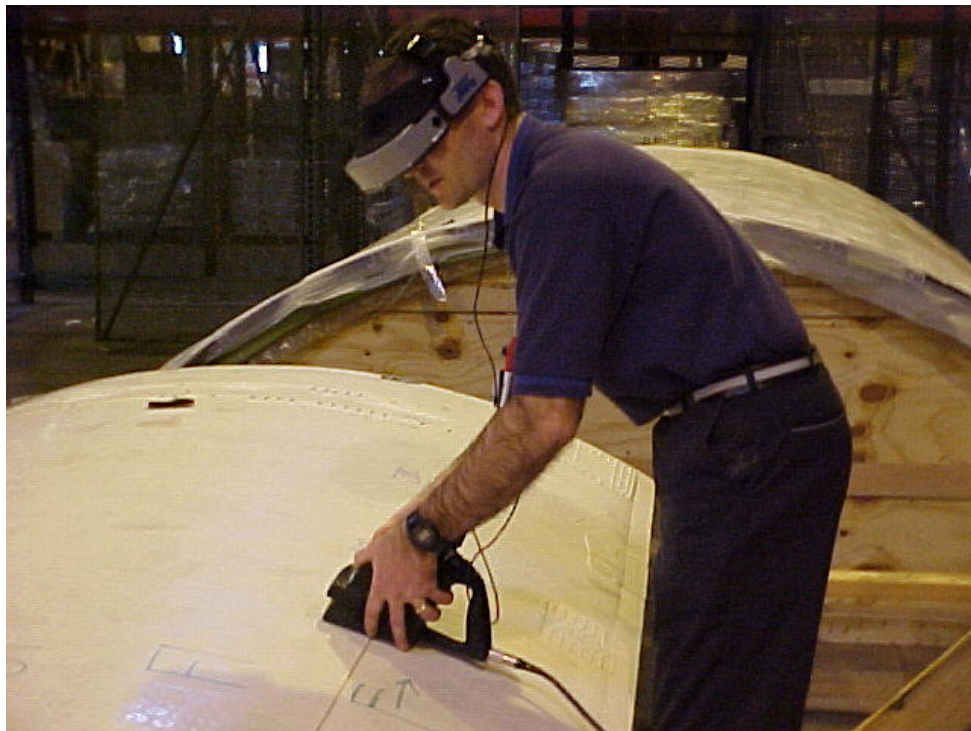
Figure F-18. Photograph of MOI inspection using wearable monitor.

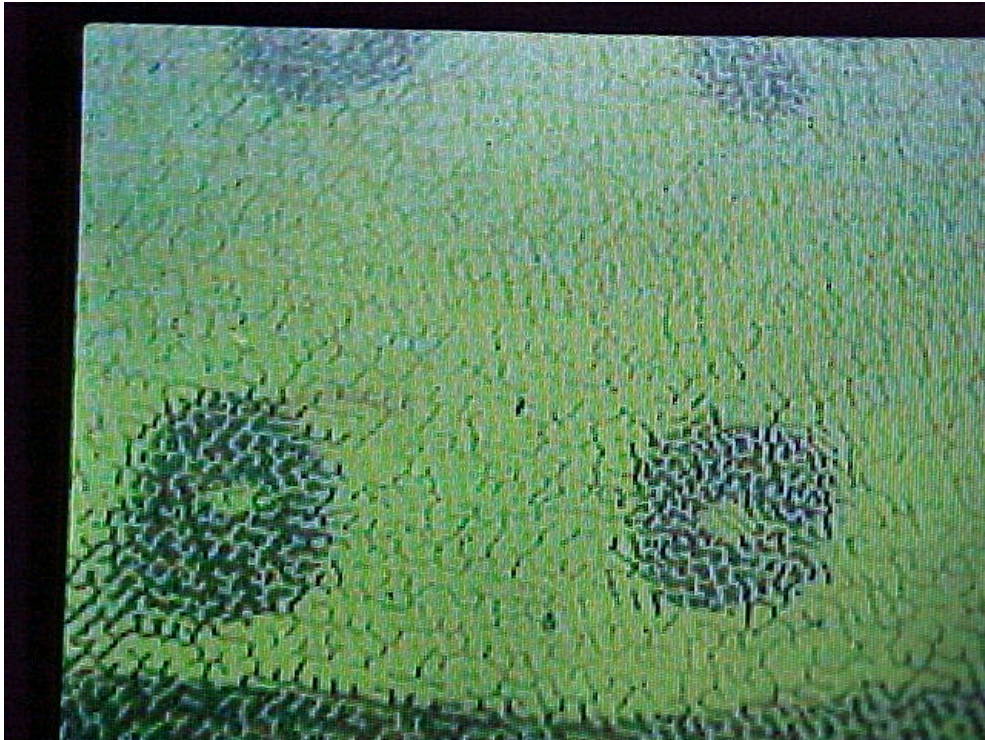
Figure F-19. Screen representation of MOI indication at rivet #4 between BS 380 and 400 on the lower row of the longitudinal lap joint at stringer 4L.

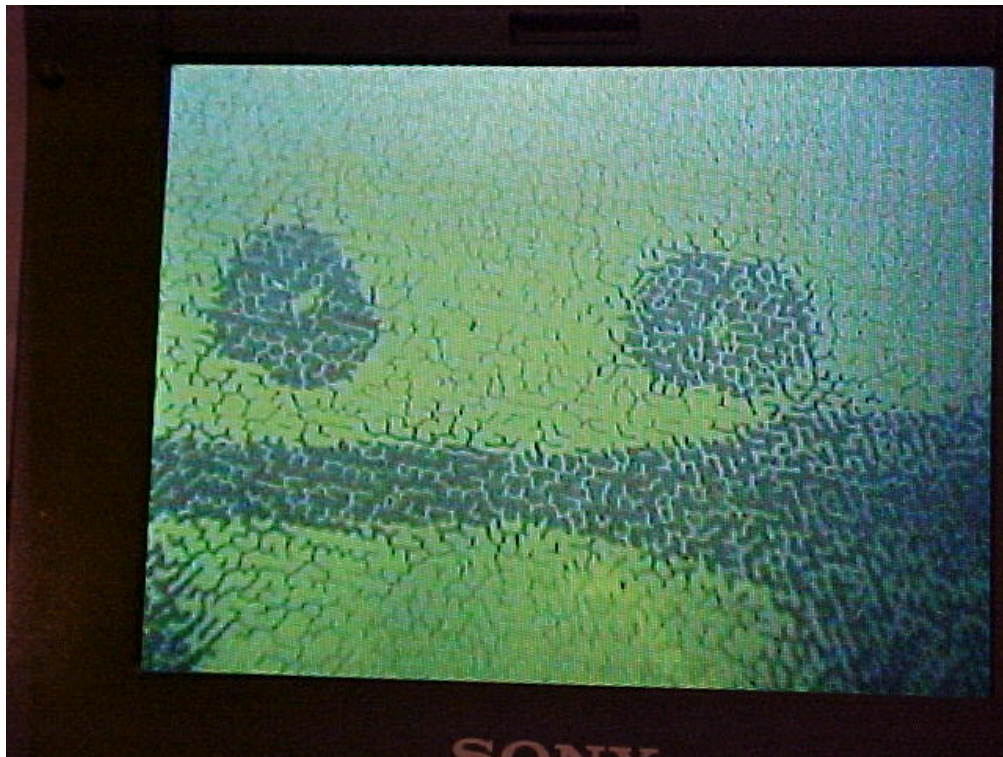
Figure F-20. Screen representation of MOI indication at rivet #5 between BS 380 and 400 on the lower row of the longitudinal lap joint at stringer 4L.

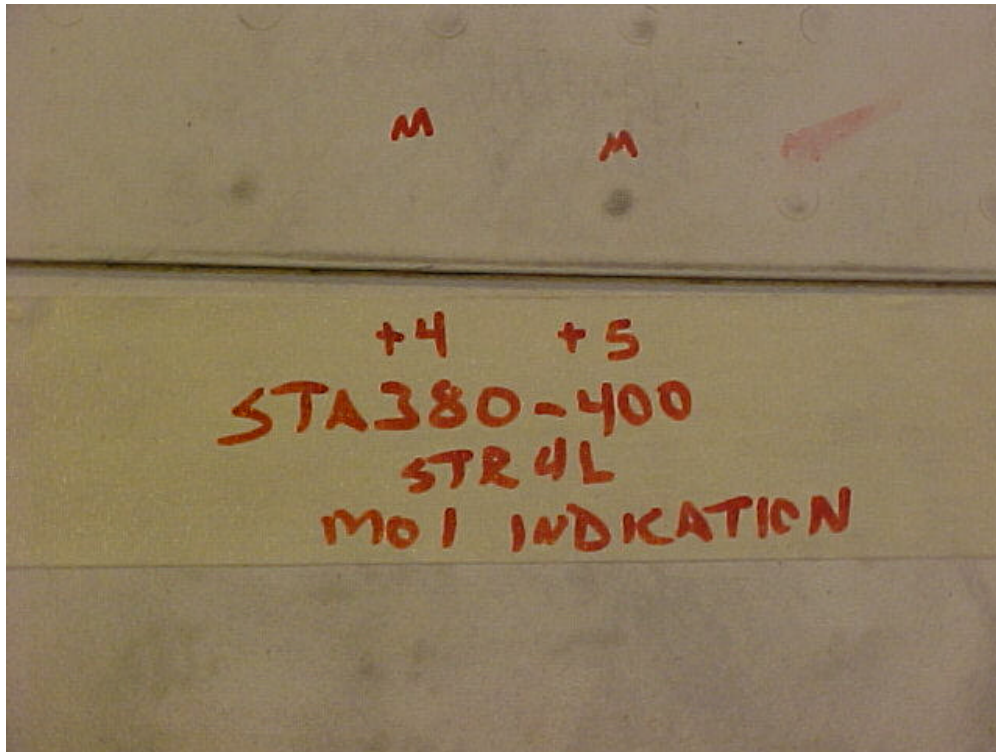
Figure F-21. MOI indications (2 indications at 2 fasteners) found between BS 380 and BS 400 on the lower row of the longitudinal lap joint at stringer 4L.

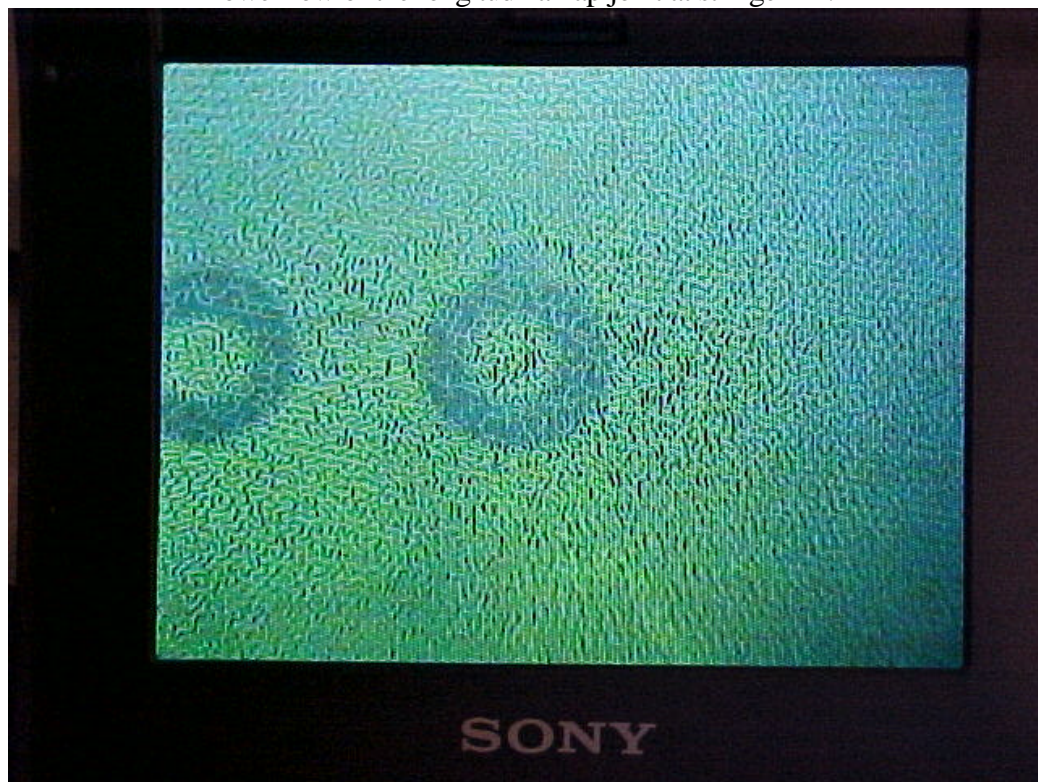
Figure F-22. Screen representation of MOI indication at rivet at BS 870 between stringer 2R and 3R on the circumferential butt joint.

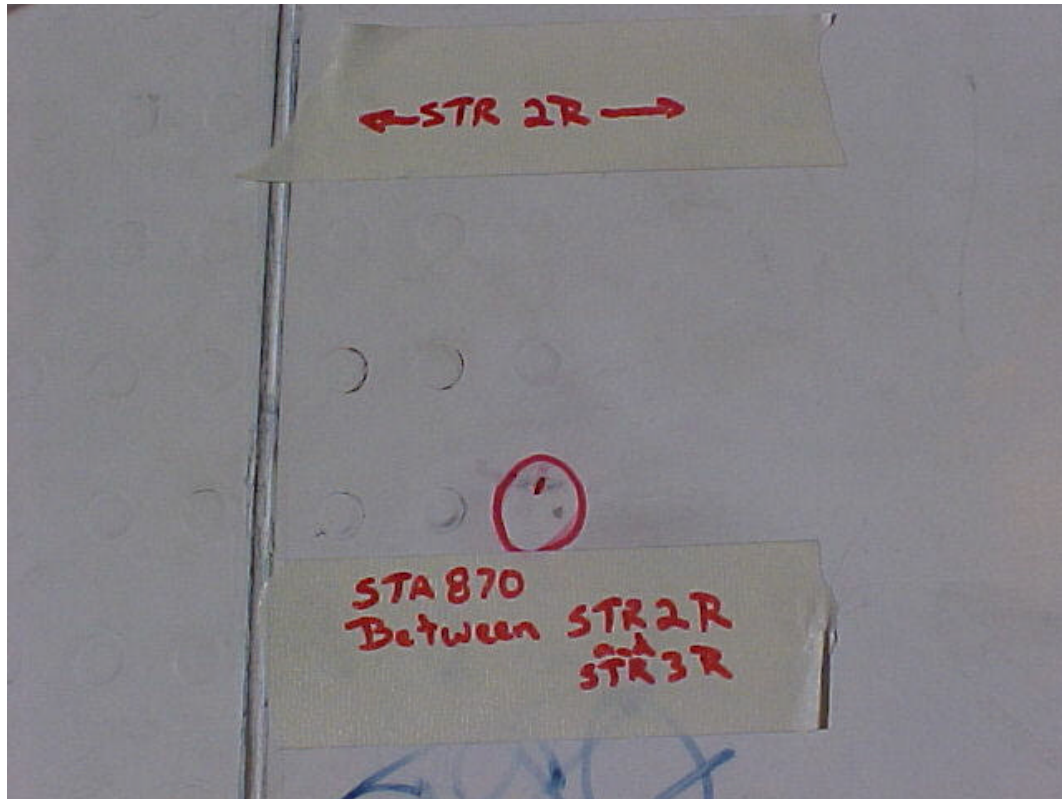
Figure F-23. MOI indication (1 indication at 1 fastener) found at BS 870 between stringer 2R and 3R on the circumferential butt joint.

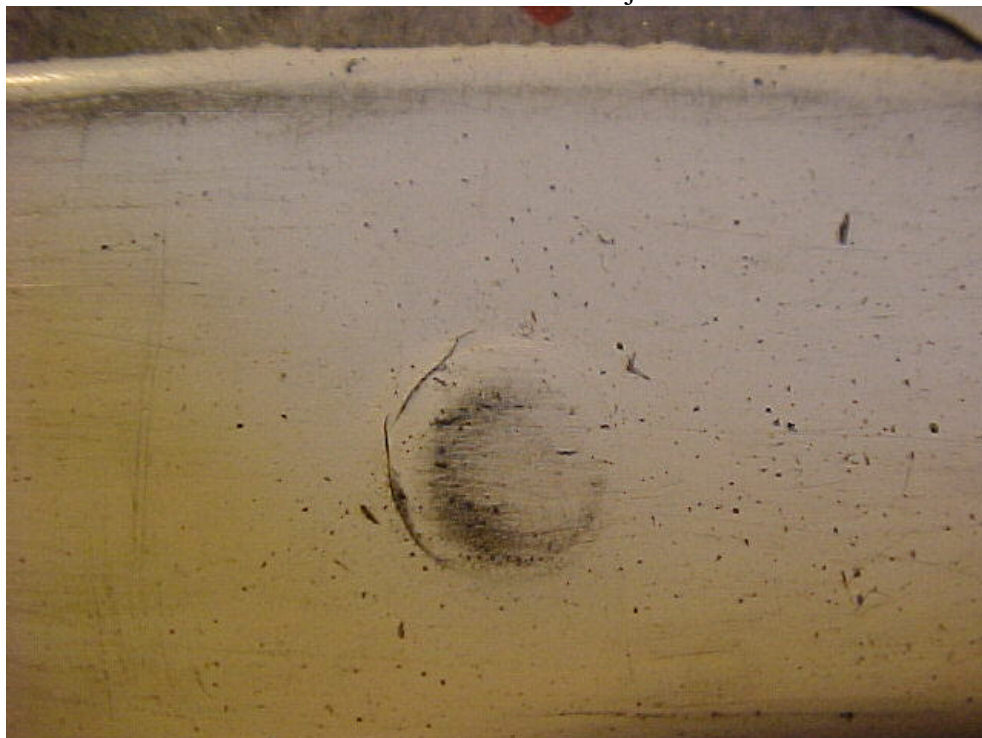
Figure F-24. Location of MOI indication found at BS 950F, rivet #6 (aft side) on the lower row of the longitudinal lap joint at stringer 4L.

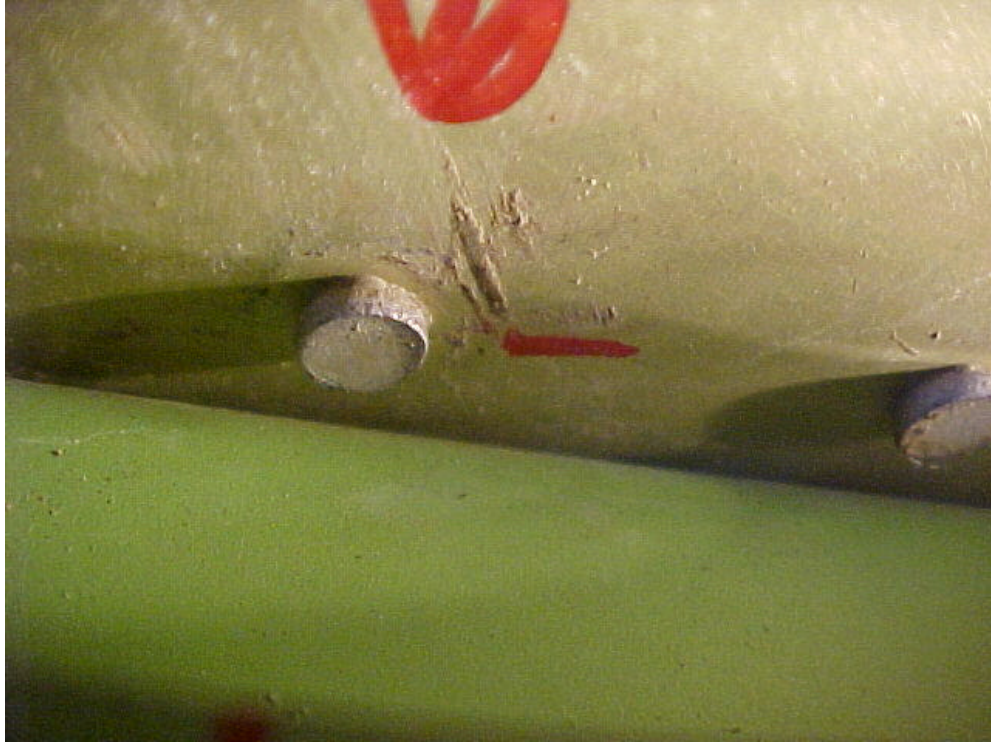
Figure F-25. Inside shot of location of MOI indication found at BS 950F, rivet #6 (aft side) on the lower row of the longitudinal lap joint at stringer 4L.

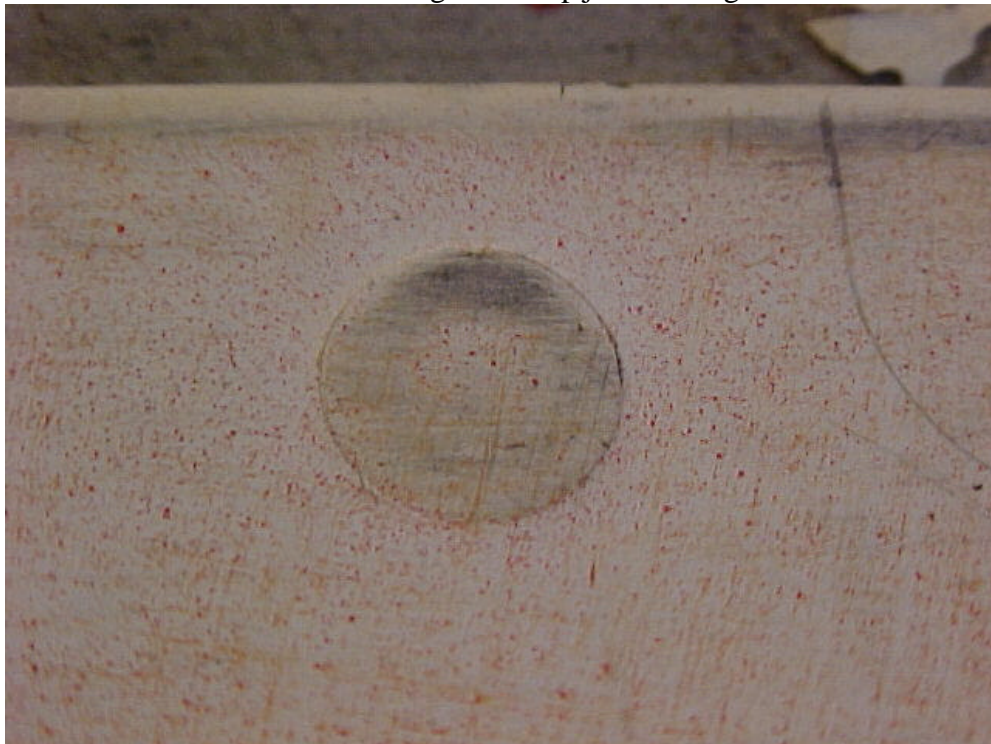
Figure F-26. Location of MOI indication found at BS 950C, rivet #9 (aft side) on the lower row of the longitudinal lap joint at stringer 4L.

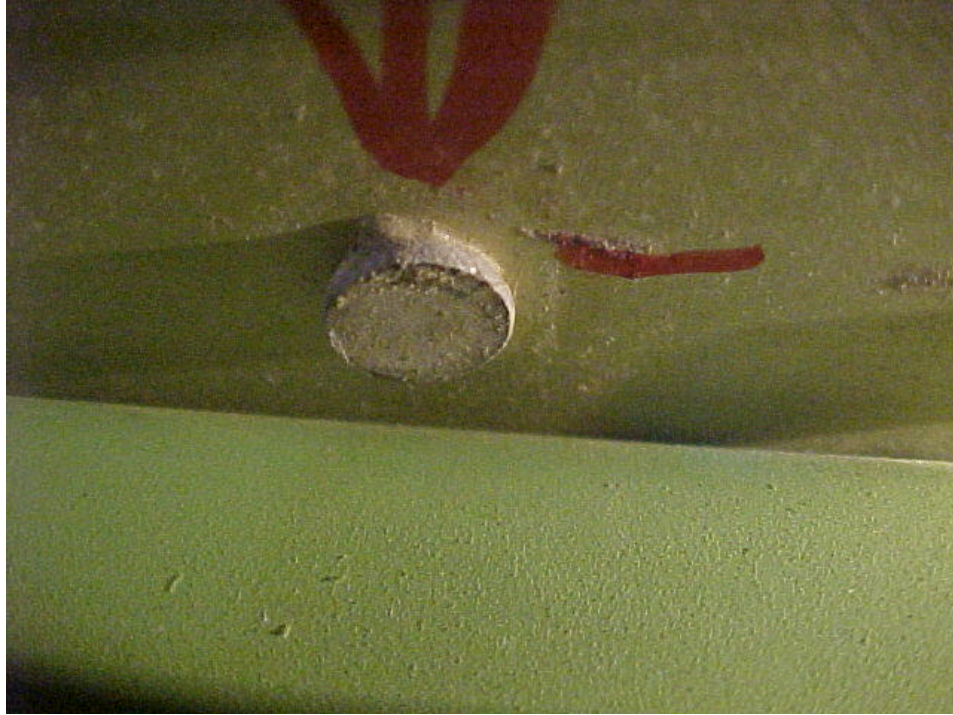
Figure F-27. Inside shot of location of MOI indication found at BS 950C, rivet #9 (aft side) on the lower row of the longitudinal lap joint at stringer 4L.

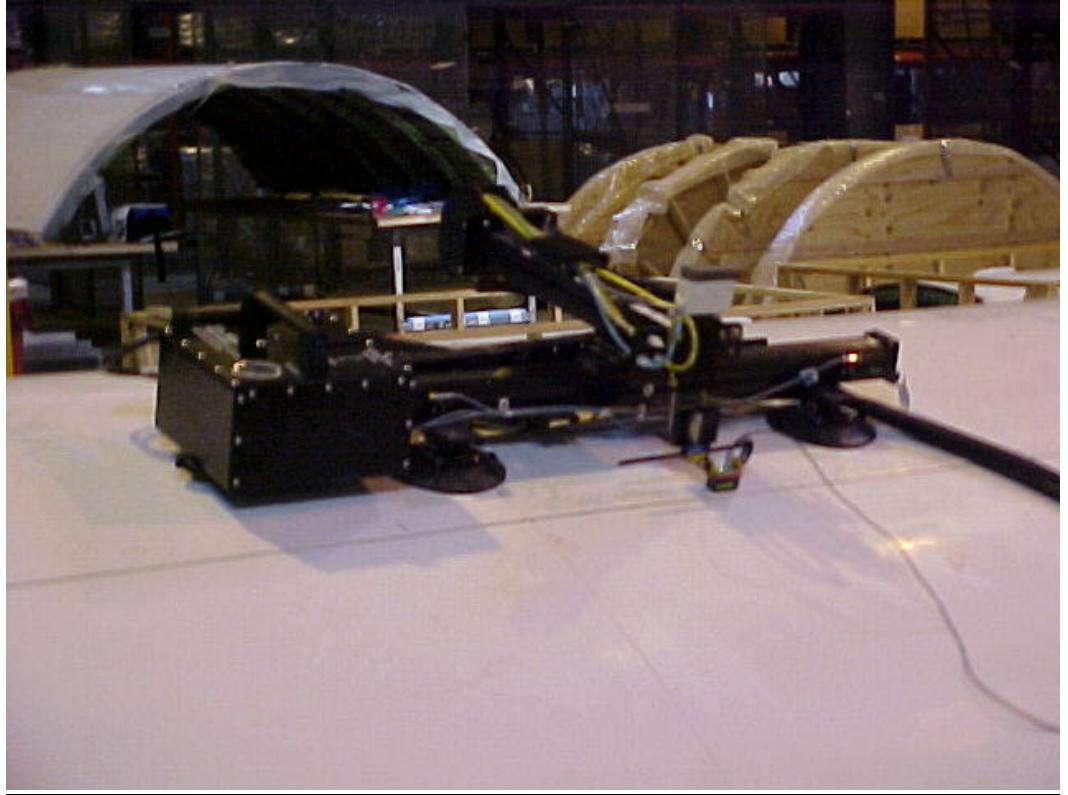
Figure G-1. Photograph showing track and translator of the C-scan system.

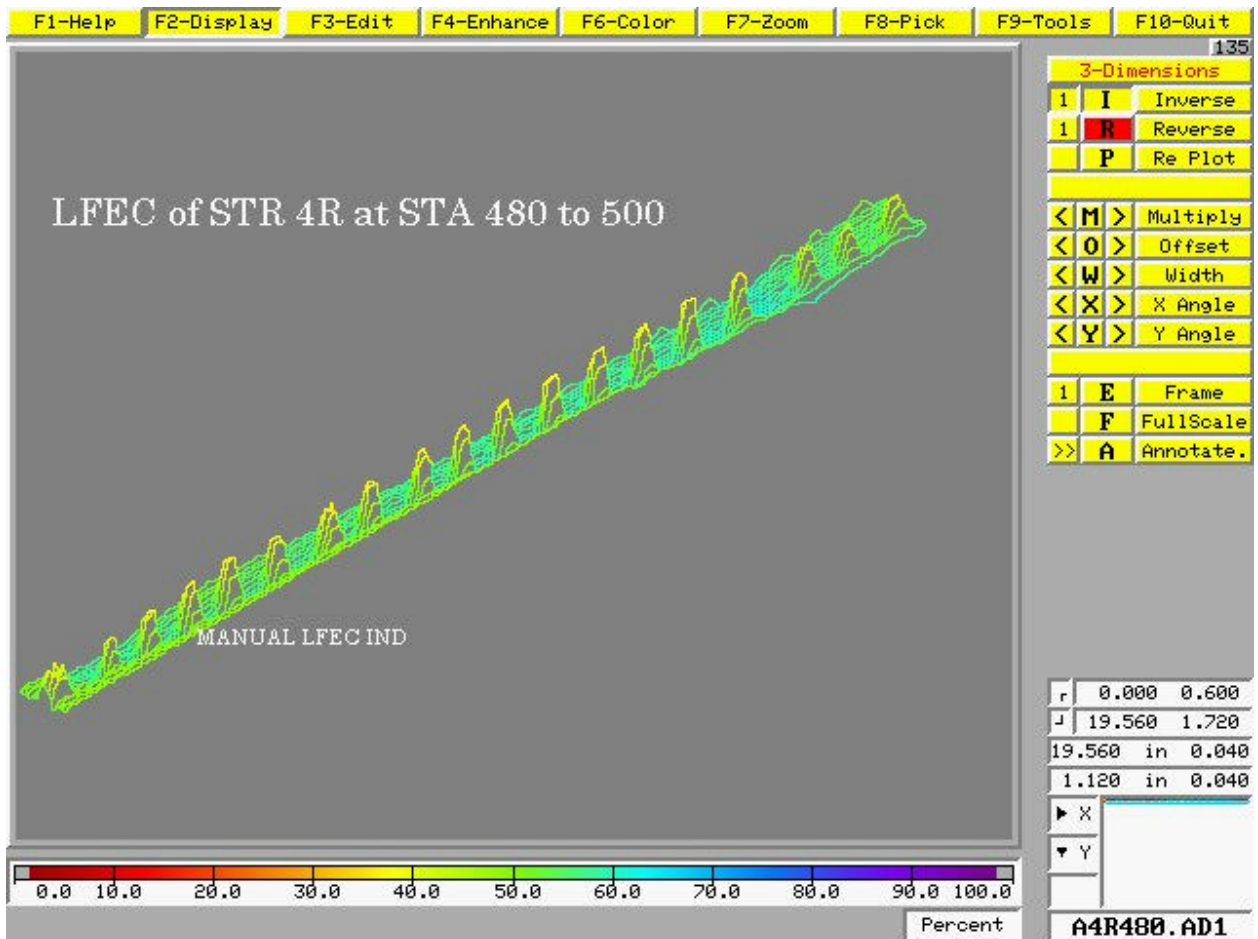
Figure G-82. 3-D Screen representation of the Eddy Current C-scan inspection showing lower row of fasteners on stringer 4R, between BS 480 and BS 500.

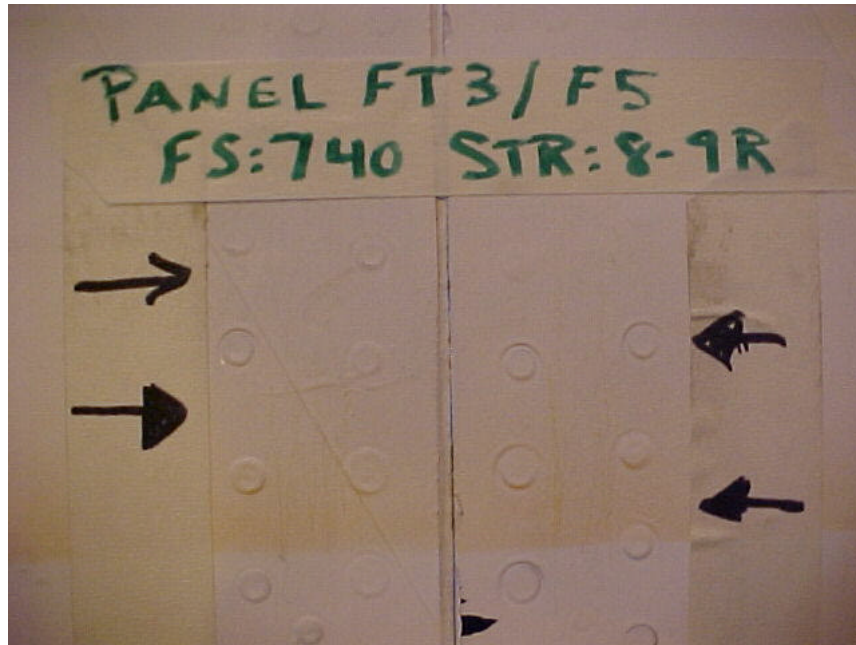
Figure H-3. Photograph of location of tear strap indication at BS 740 between stringers 8R and 9R.

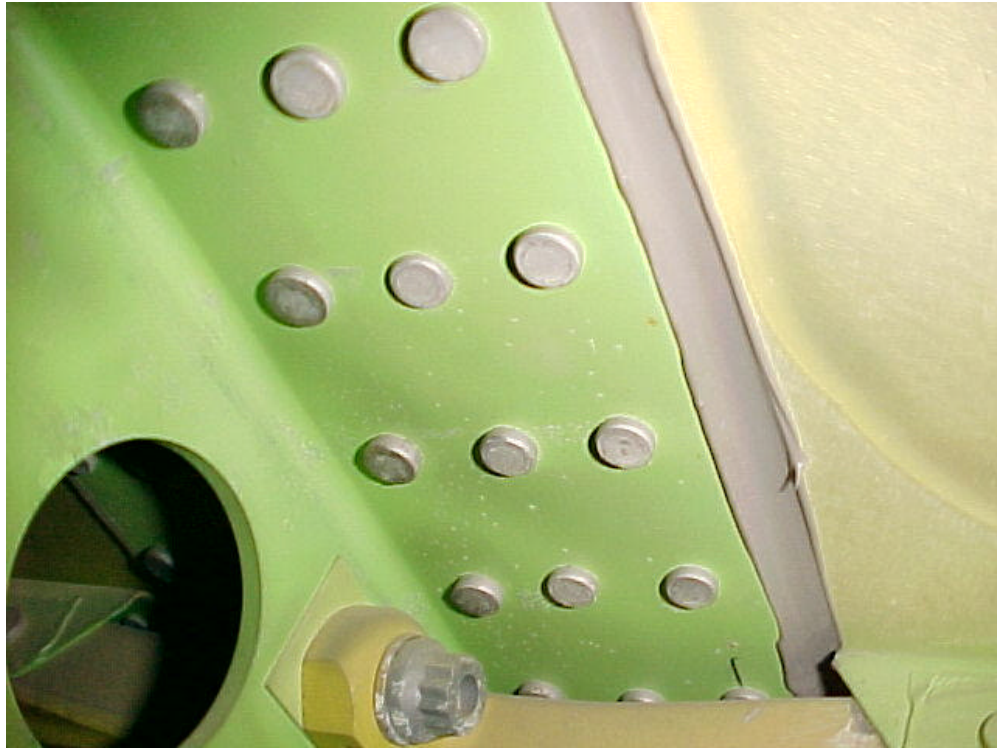
Figure H-8. Photograph showing internal view of tear strap indication area at BS 740 between stringers 3L and 4L. No explanation for the indication could be found.

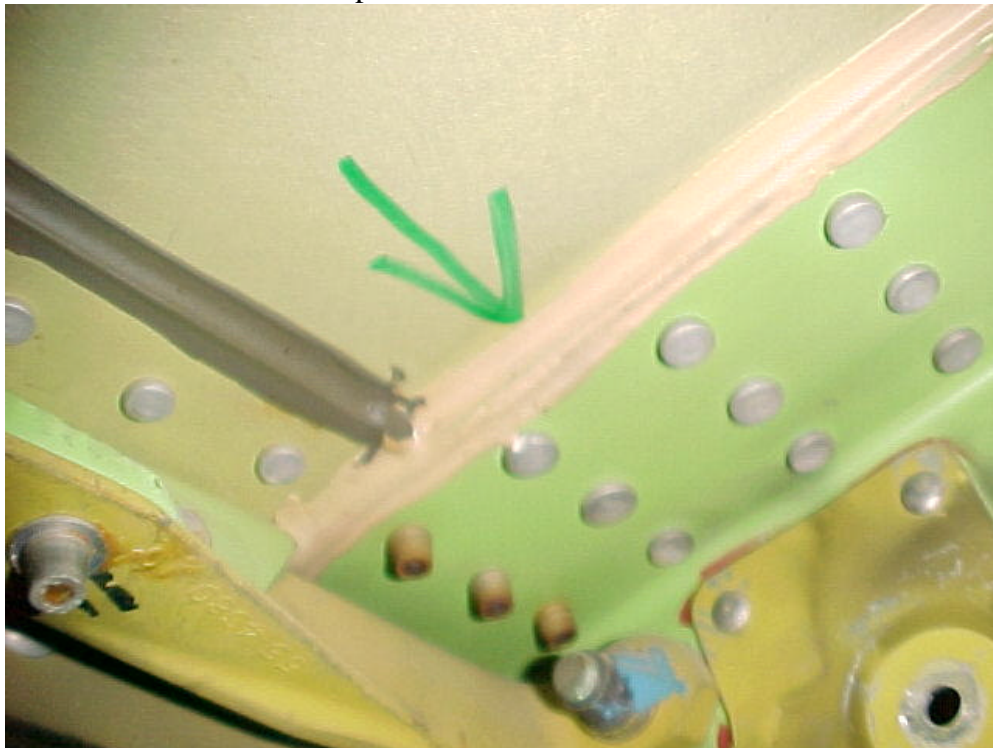
Figure H-9. Photograph showing internal view of tear strap indication area at BS 740 between stringers 3L and 4L. No explanation for the indication could be found.

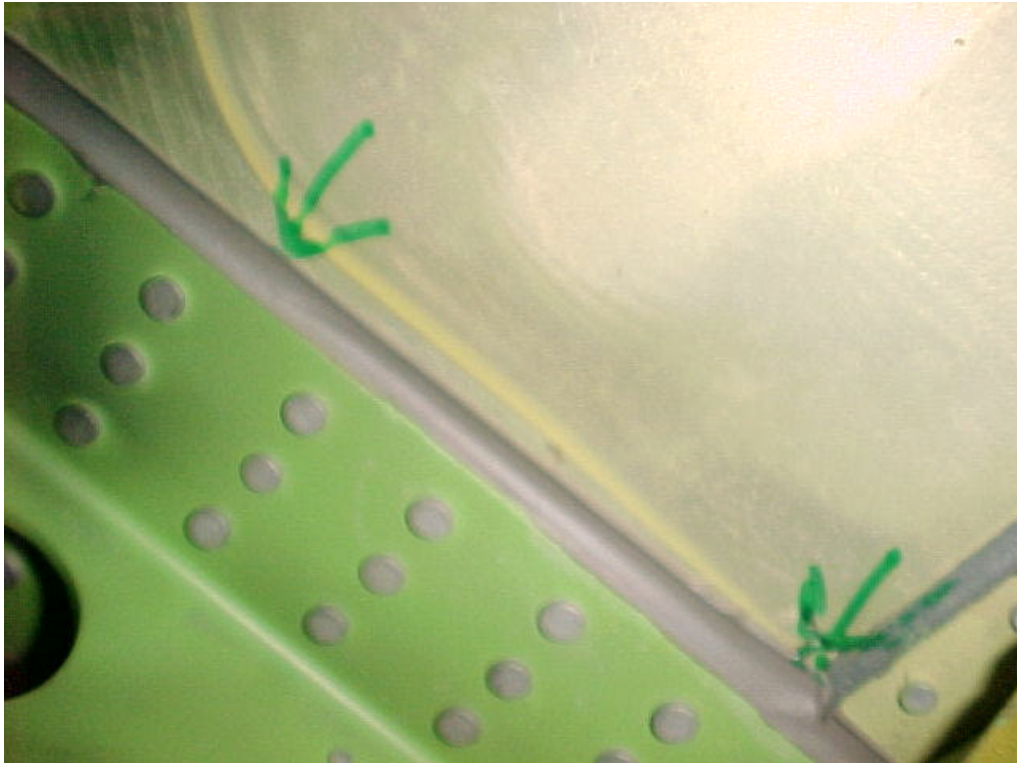
Figure H-10. Photograph showing internal view of tear strap indication area at BS 740 between stringers 3L and 4L. No explanation for the indication could be found.

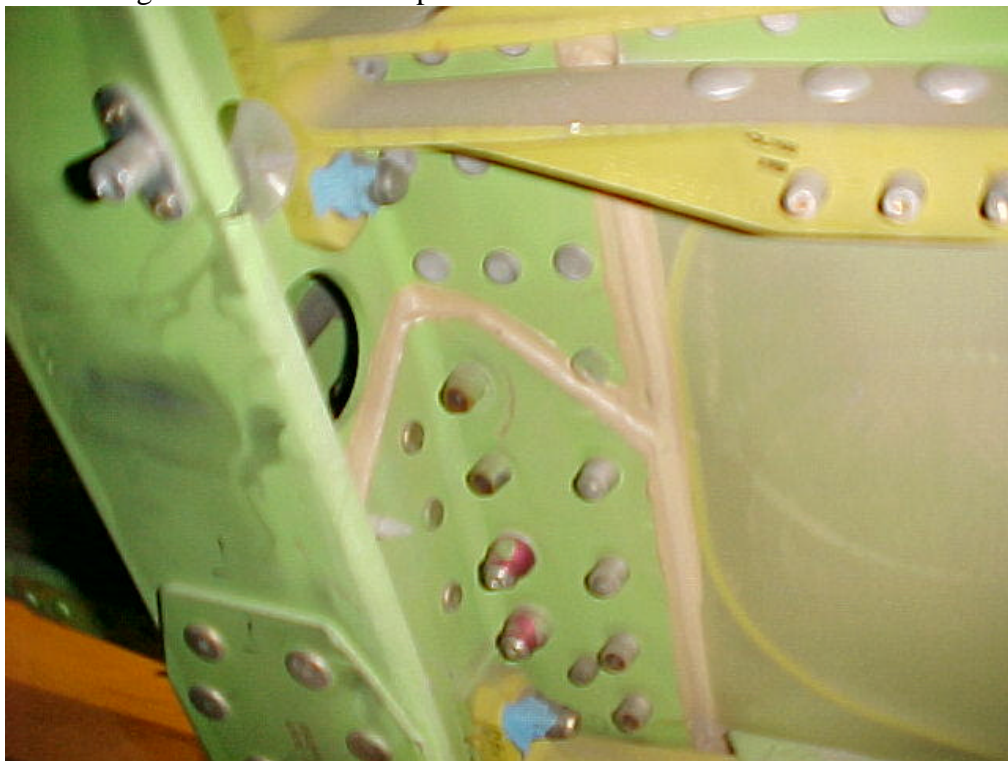
Figure H-11. Photograph showing internal view of tear strap indication area at BS 740 between stringers 8R and 9R. No explanation for the indication could be found.

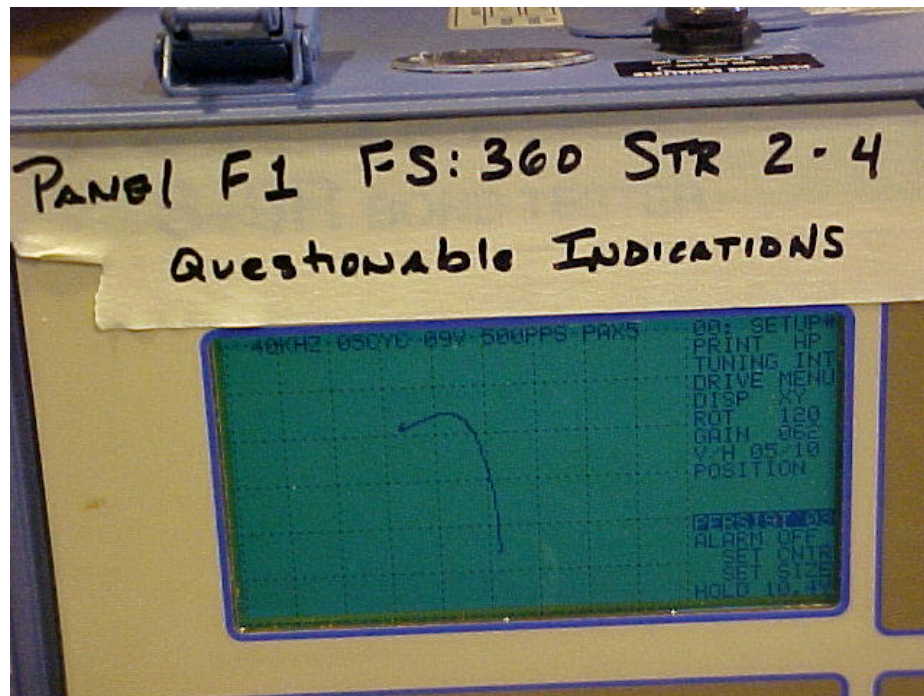
Figure H-12. Screen representation of tear strap indication at BS 360 between stringers 2R and 4R.
